# Performance of hurricane shutters under impact by roof tiles

# George Fernandez, Forrest J. Masters<sup>1</sup>, Kurtis R. Gurley<sup>\*</sup>

# ABSTRACT

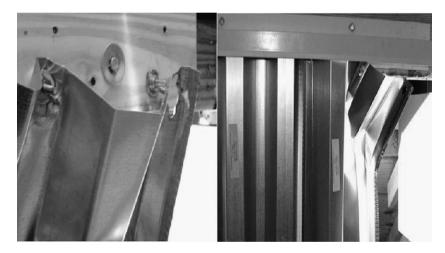
Fig. 12. Examples of direct mount tear (left) and track mount pull-out (right).

In many tests, damage occurred at the installation (the interface between the panel and frame). For direct mount installation, damage is defined as the stud tearing through the panel at one stud or more. For track mount installation, damage is defined as either a pull-out or push-through of the panel from the track, such that the top edge of the panel is partially or fully separated from the track. Examples of tearing for direct mount and pull-out and push-through for track mount installation are shown in Fig. 12. Installation interface damage occurred for a small number of  $2 \times 4$  tests, and a larger portion of the tile tests. In most cases, damage at the interface is associated with a more severe panel deflection. Each of the individual tests that resulted in installation damage is indicated in the six graphs (Figs. 6–11) with an icon above the deflection results for a given test. These icons are defined in Fig. 5.
